Avondale Mixed Use District

Existing Features Summary

Avondale

Existing Features Notes & Aerial

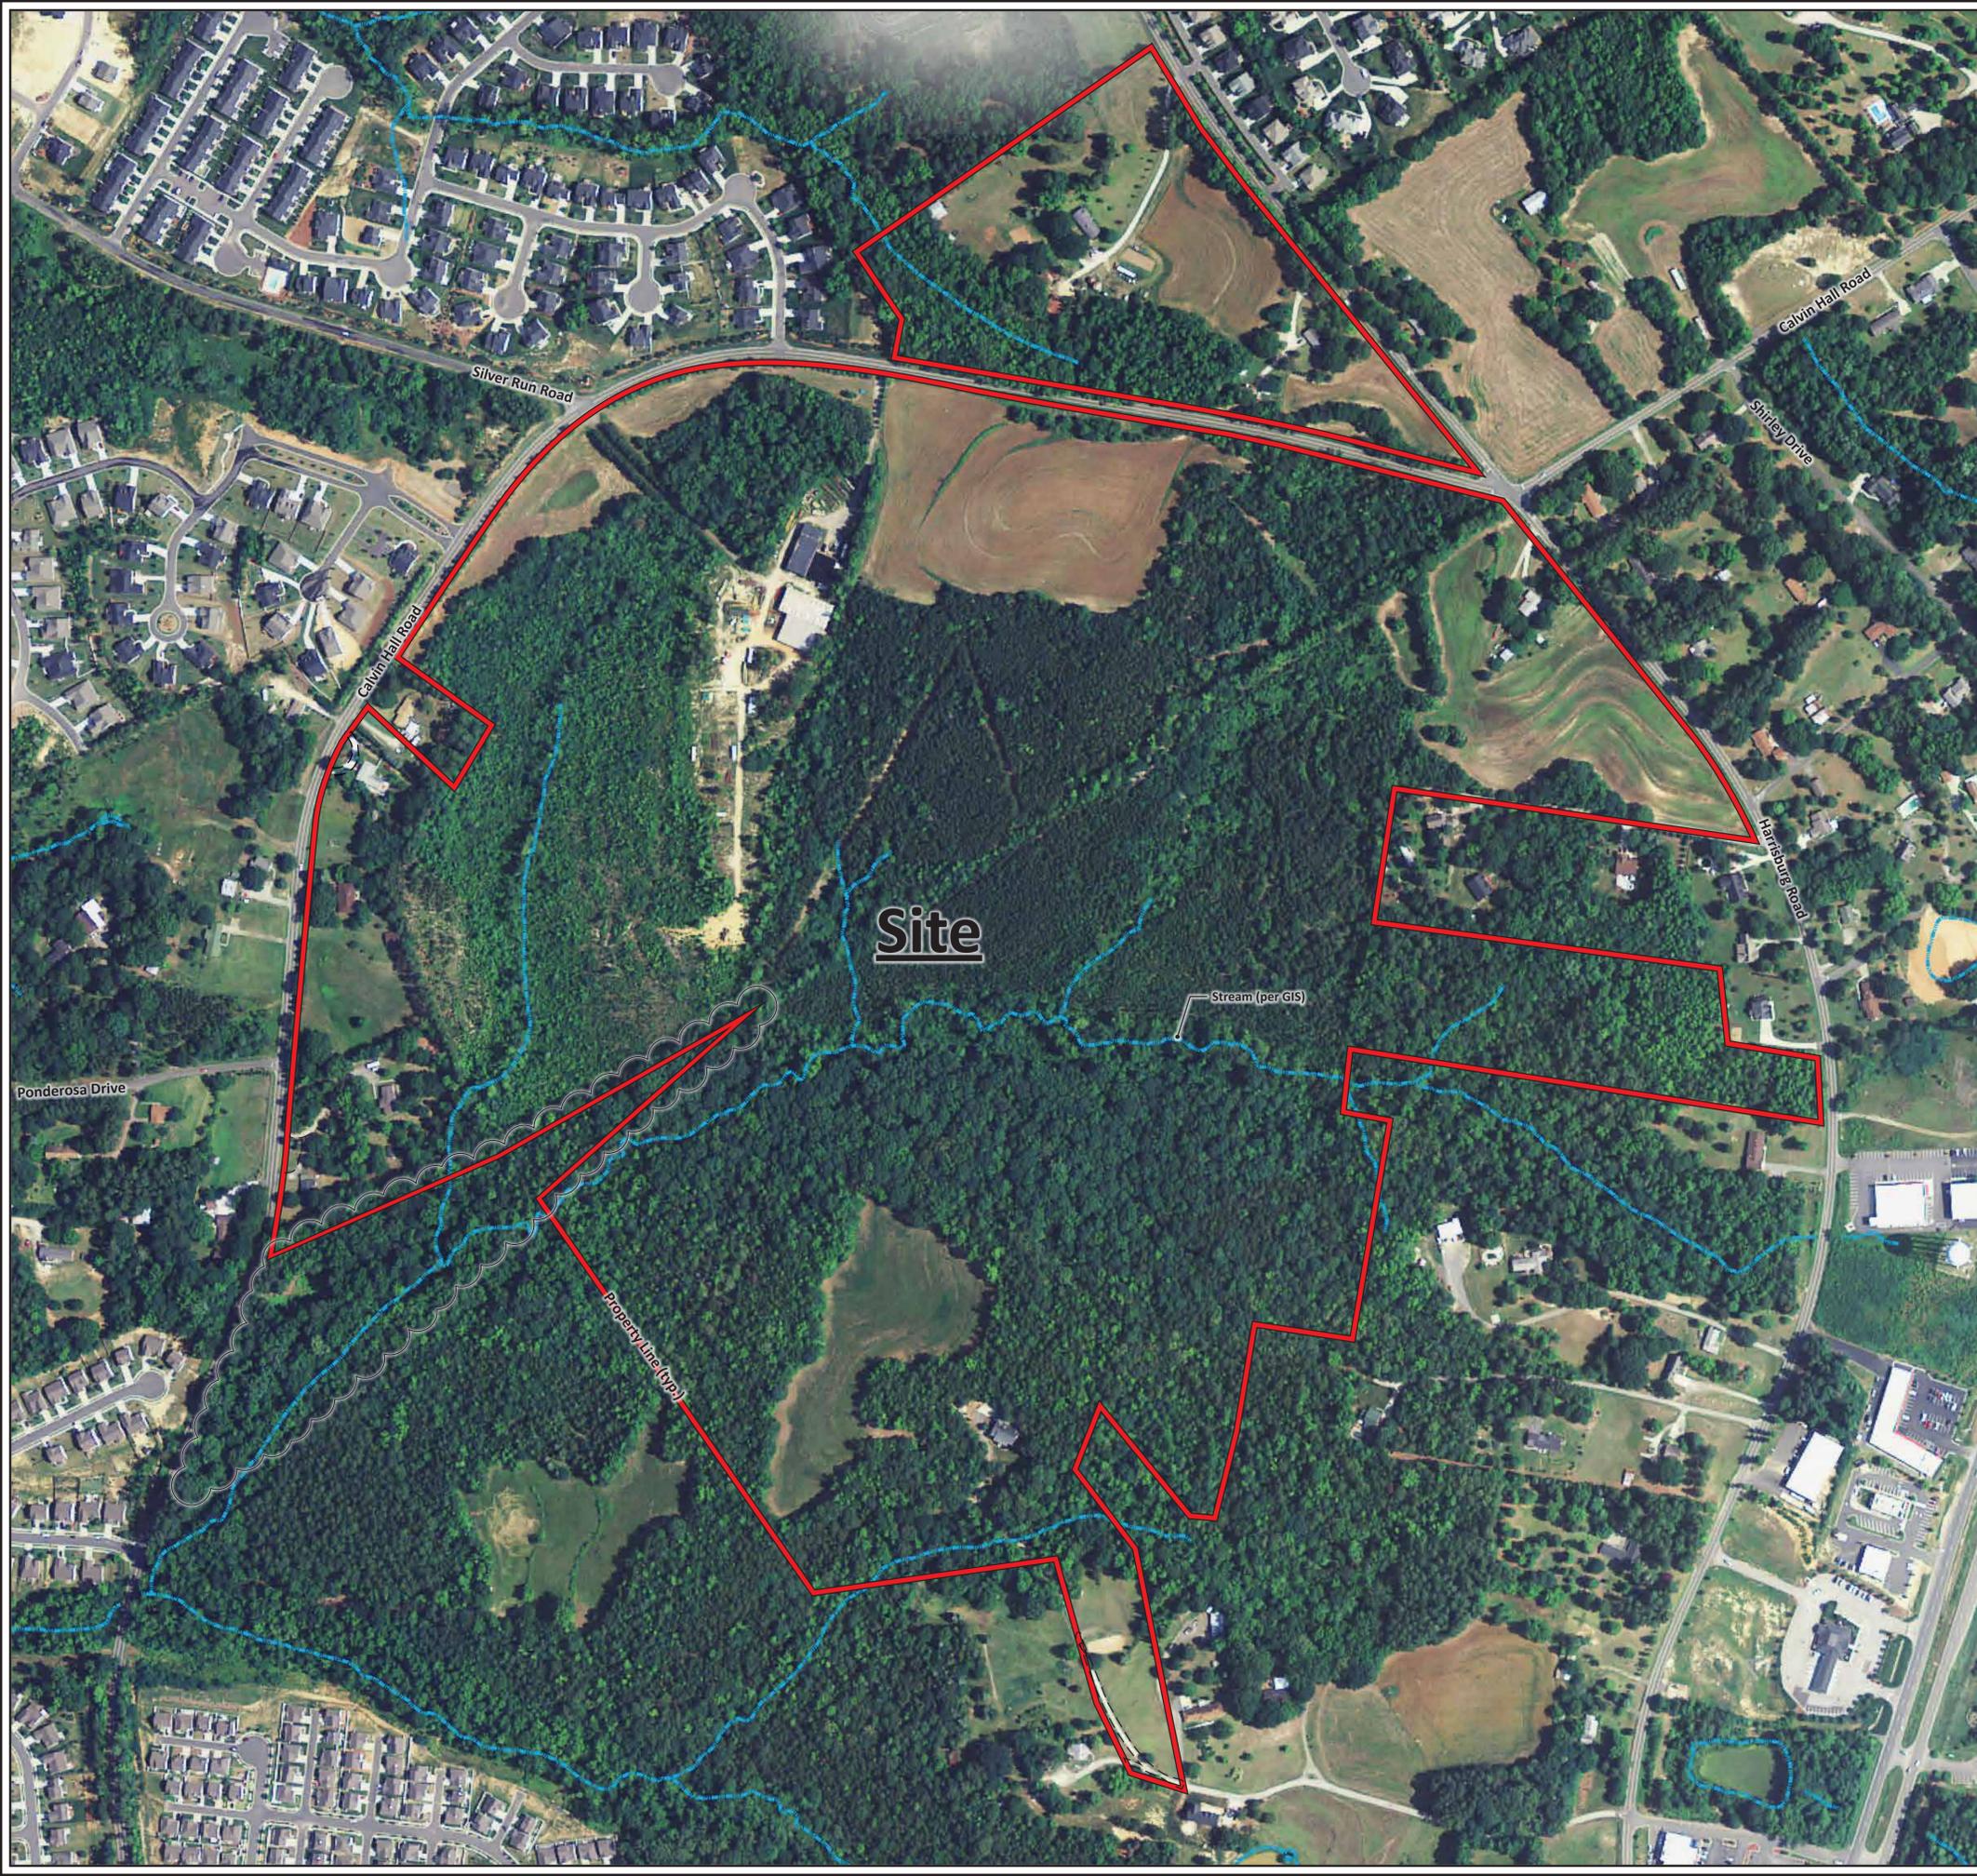
Following is a summary of Existing Features for the proposed Avondale Mixed Use District/PDD Site. Information provided has been prepared and assembled using readily available public information sources including Lancaster County GIS, fema.gov, Google Earth, and other readily available sources in order to inventory the natural, manmade, and legal features of the site (as a part of the Master Plan Requirements - Section 13.12.4 of the Lancaster County Code of Ordinances). In addition to illustrating these features as they appear where the development is taking place, the use of adjoining properties has been noted on sheet 2 (Existing Features).

- a) **Wooded Areas-** The project area consists of forested land areas that are denoted by the legend on sheet 2 Existing Features. Typical overstory vegetation includes sweetgum (*Liquidambar styraciflua*), ironwood (*Carpinus caroliniana*), white oak (*Quercus alba*), and American sycamore (*Platanus occidentalis*). Common understory species found on site include Eastern red cedar (*Juniperus virginiana*), American holly (*Ilex opaca*), Christmas fern (*Polystichum acrostichoides*), ground cedar (*Diphasastrum digitatum*), Japanese honeysuckle (*Lonicera japonica*), muscadine (*Vitis rotundifolia*), poison ivy (*Toxicodendron radicans*), and sticky willy (*Galium aparine*). These trees range in size, with sizes ranging from 2"- 30" in diameter.

- a) Vehicle accommodation areas include various driveways, unpaved paths, and partially paved circulation areas that are illustrated on sheet 2 (Existing Features). These features have been located based on available Lancaster County aerial imagery. There do not appear to be improved designated parking spaces on site. Driveway areas appear to be unimproved and wide enough to accommodate a single lane of traffic and have no apparent designated direction of travel. An exception exists on parcel 0005-00-078.00 where there is an existing quasi-industrial type business, which includes various scattered outdoor storage and unimproved vehicular areas. This site includes a large warehouse type building along with several small storage type structures.

- e) Above ground utility lines clearly visible through Google Earth and Lancaster County aerial imagery have been illustrated on sheet 2 (Existing Features). Exact locations of these lines, any additional lines, and other utility facilities (including public fire hydrants) were not identified through an inspection of the above mentioned data. The applicant is gathering additional information, including a boundary survey, to better understand these features.
